NPDES Inspection Report

Permit # WA0002062

Puget Sound Naval Shipyard

September 23, 2015

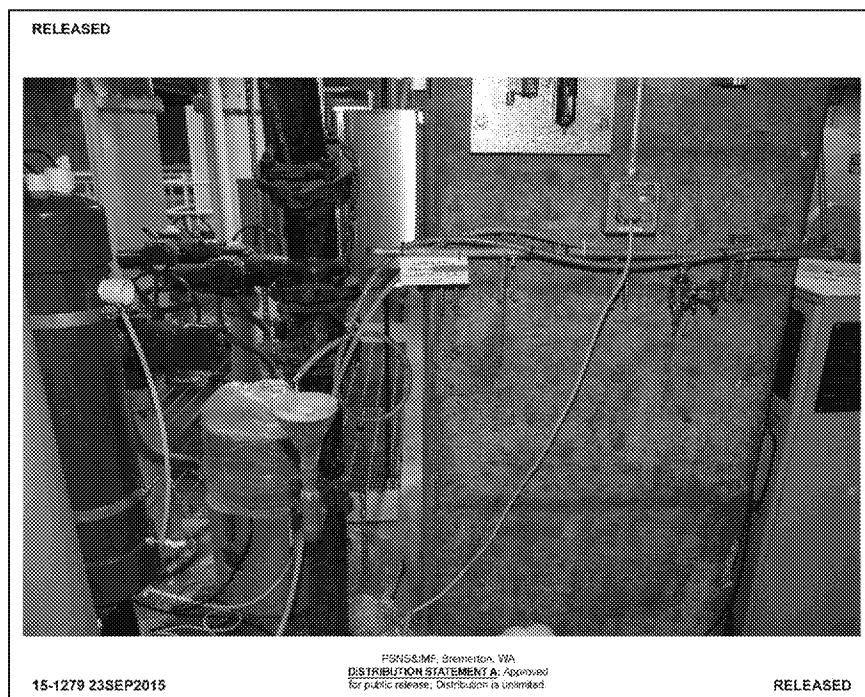
I also inspected the sampling location for discharges from Dry Dock 6 (**Photo 1**). Ms. Aylward explained that plastic tubing was recently installed to replace old stainless steel piping at this sample port.

During the inspection, I noted that a lab report dated August 10, 2015 documented a total recoverable copper concentration of 138 ug/L in an effluent sample collected for outfall 019 at Dry Dock 6. Although this concentration exceeds the permitted daily maximum limit of 0.033 mg/L, Ms. Aylward explained that the measurement was attributed contamination from the sample pipe, not the actual discharge. Ms. Aylward said that she consulted the facility's legal counsel and showed me typed notes documenting a phone call with Chae Park at the NPDES Compliance Unit. The notes documented the facility's notification to the EPA that this test result would not be included in the DMR because it was deemed unrepresentative of the discharge. Ms. Aylward stated that the facility was confident that the test result was unrepresentative because the sample was collected at a time when there was neither a rain event nor a vessel in the dry dock. After this incident, the sample pipe was replaced (**Photo 1**) with plastic tubing.

Photo 1 / 15-1279_RELEASED_JTK_001 – Sampling port for outfall 019 at Dry Dock #6. The facility recently replaced stainless steel piping with plastic tubing at this sample port.

I recommended that the facility continue to carefully document and notify EPA of any future decisions to omit test results from DMRs due to unrepresentative sampling.

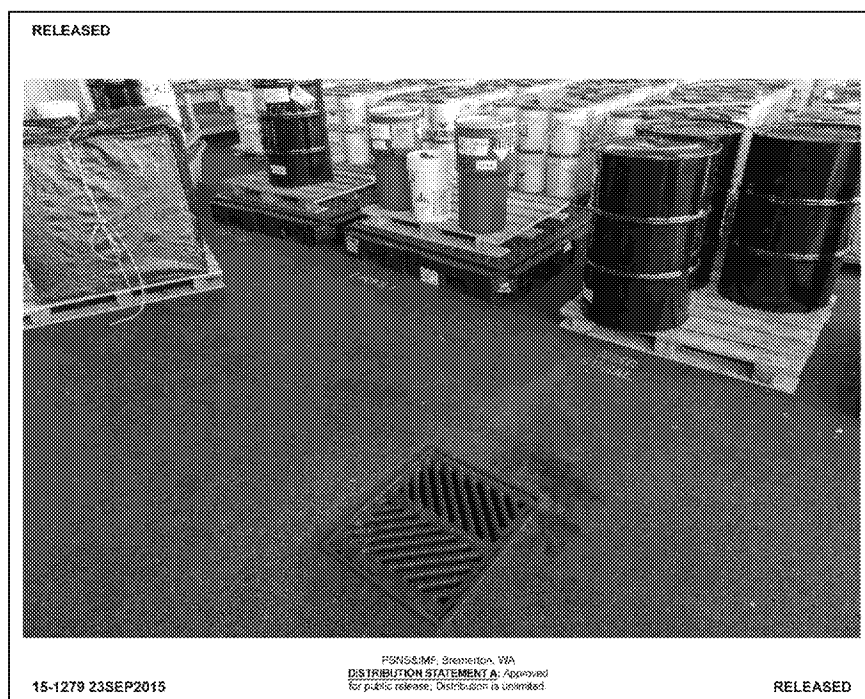
I also inspected a stormwater collection system at building 944, which is used as a less than 90 day accumulation area for hazardous waste. I noted that floor drains (**Photo 2**) are located under a roofed staging area (**Photo 3**) for hazardous waste. The facility explained that stormwater from the floor drains is pumped to a storage tank (**Photo 4**), which is drained in batches to the storm sewer system.

I noted that floor drains (**Photo 2**) are located under the roofed staging area (**Photo 3**) where hazardous waste is accumulated at building 944. Although this area is walled on three sides, stormwater can enter through the open entryway or through gaps at the base of the walls. Fluid from the floor drains is pumped to a storage tank (**Photo 4**), which is drained in batches to the storm sewer system.

Photo 2 / 15-1279_RELEASED_JTK_004 – View of a floor drain in the hazardous waste staging area at building 944

I noted that a hazardous waste spill in this area could potentially come in contact with stormwater run-on, and if a spill entered a floor drain, it could commingle with stormwater in the storage tank. I suggested that the facility consider methods to further minimize the potential for stormwater to come into contact with hazardous waste in this area.

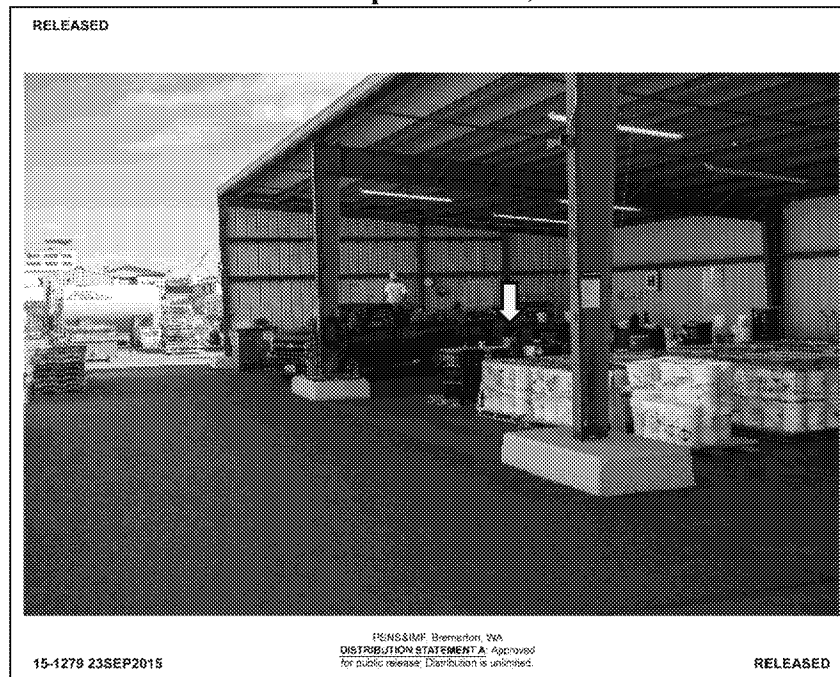
Photo 3 / 15-1279_RELEASED_JTK_002 – Southwesterly view of the hazardous waste staging area at building 944. The yellow arrow indicates the approximate location of the floor drain that appears in the previous photo. Stormwater is pumped from floor drains in this area to the “rainwater overflow tank” that appears in the background on the left and in the next photo.

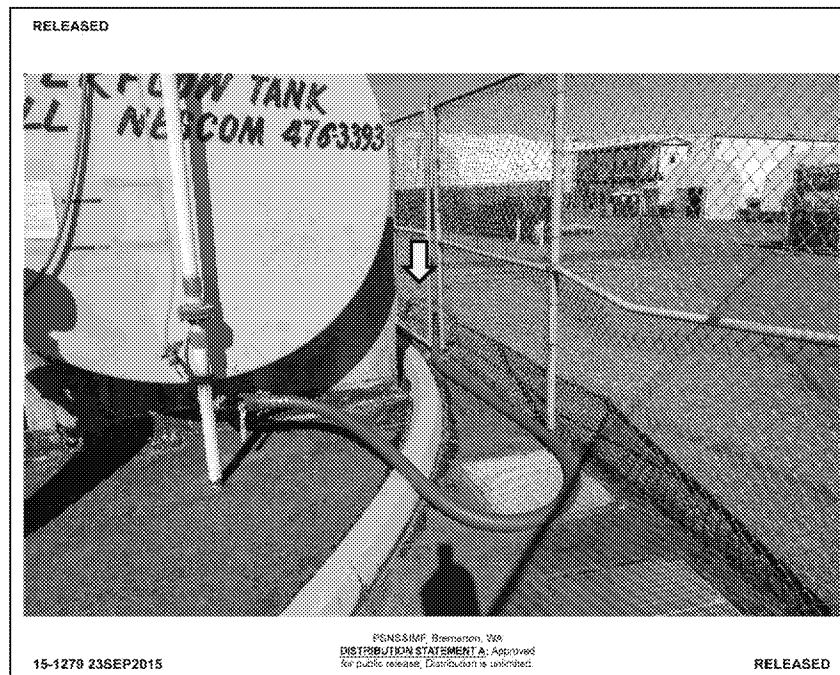
Photo 4 / 15-1279_RELEASED_JTK_003 – Westerly view of the “rainwater overflow tank” that appears in the previous photo. The tank is connected to a green hose that periodically discharges to a storm drain located outside the fenced area. The yellow arrow indicates the approximate location of the storm drain.
